ARMY ENGINEERING DISTRICT NORFOLK VA  
NATIONAL DAM SAFETY PROGRAM, BEAVERDAM CREEK DAM (VA-01903), BE--ETC(U)  
JUL 79 J A WALSH

Name Of Dam: BEAVERDAM CREEK  
Location: BEDFORD COUNTY, VIRGINIA  
Inventory Number: 01903

# PHASE I INSPECTION REPORT NATIONAL DAM SAFETY PROGRAM

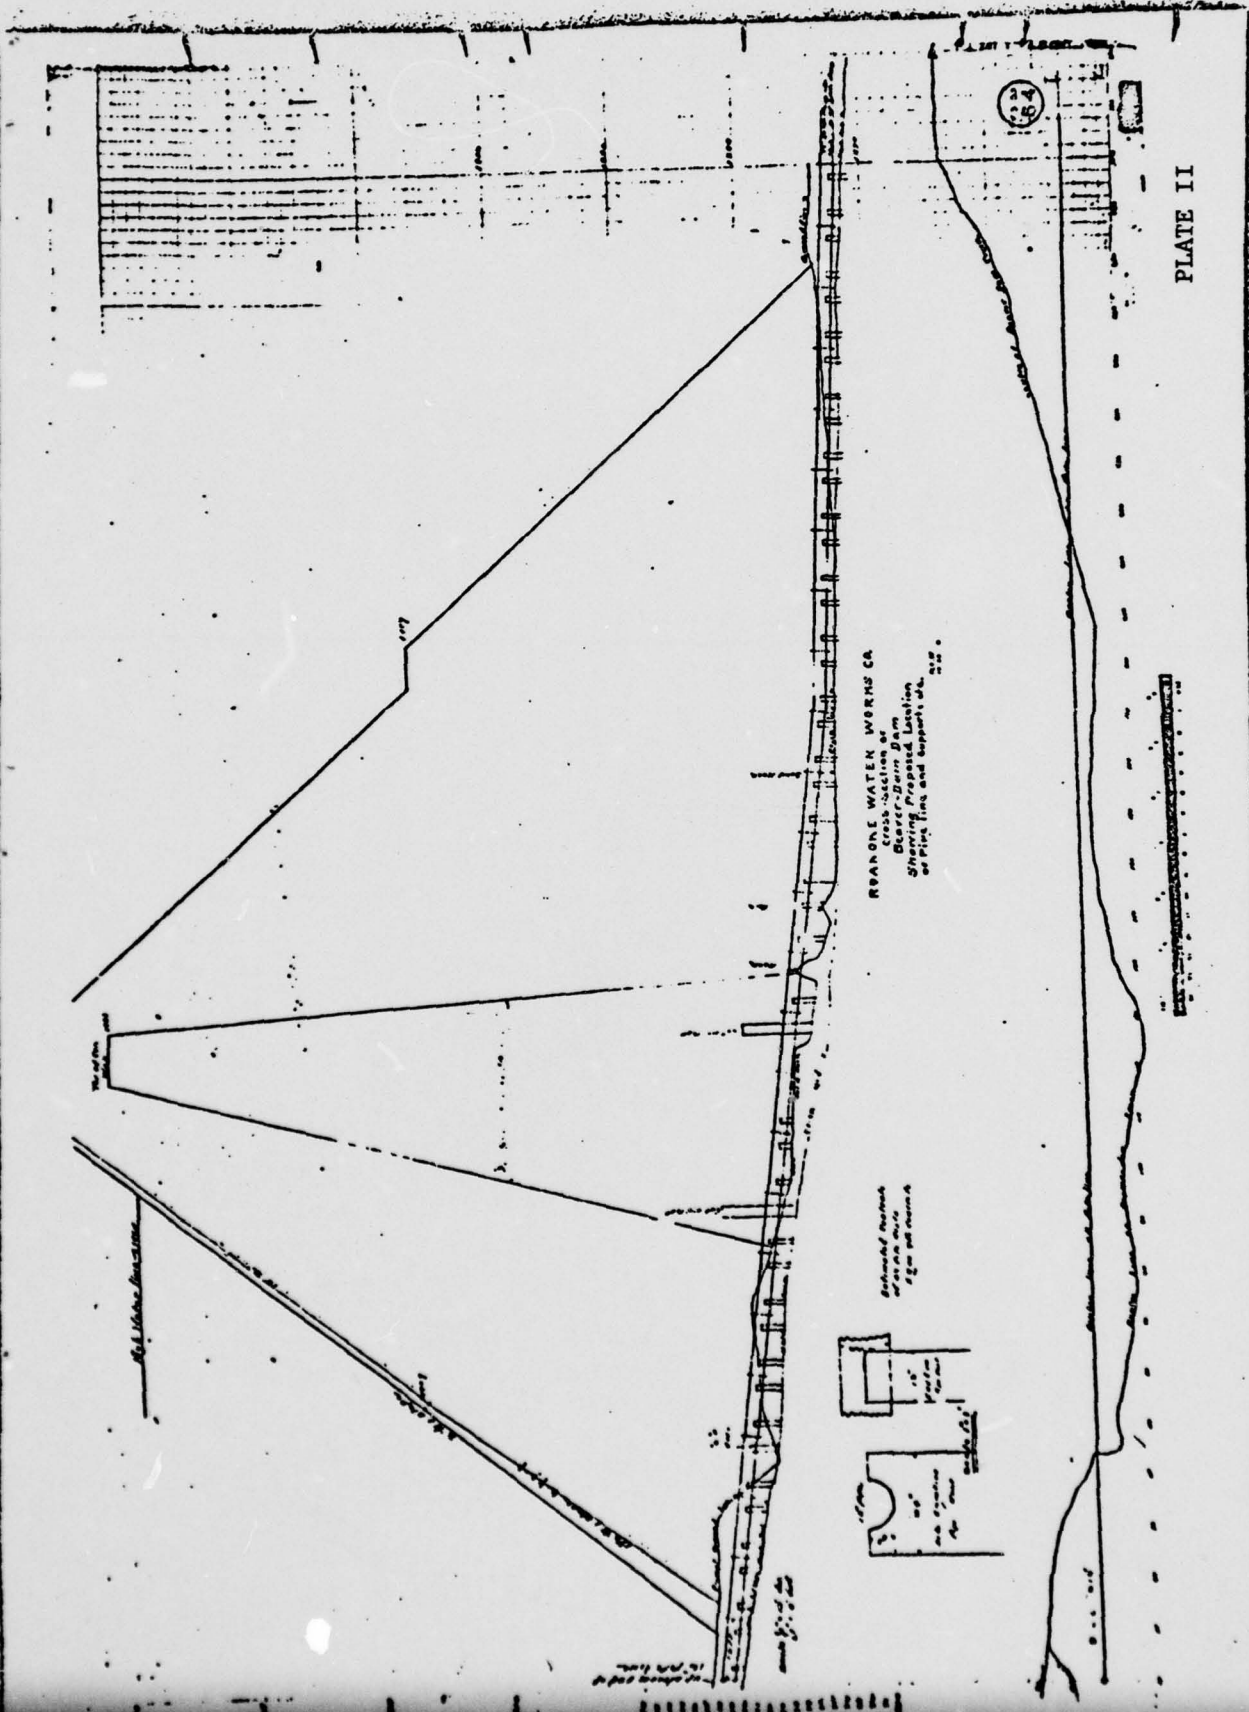
PLATE II

The embankment has an impervious core keyed into foundation bedrock with a foundation drainage system. A cross section of the dam and a hand sketch of the plan view are shown on Plates II and III Appendix I, respectively.

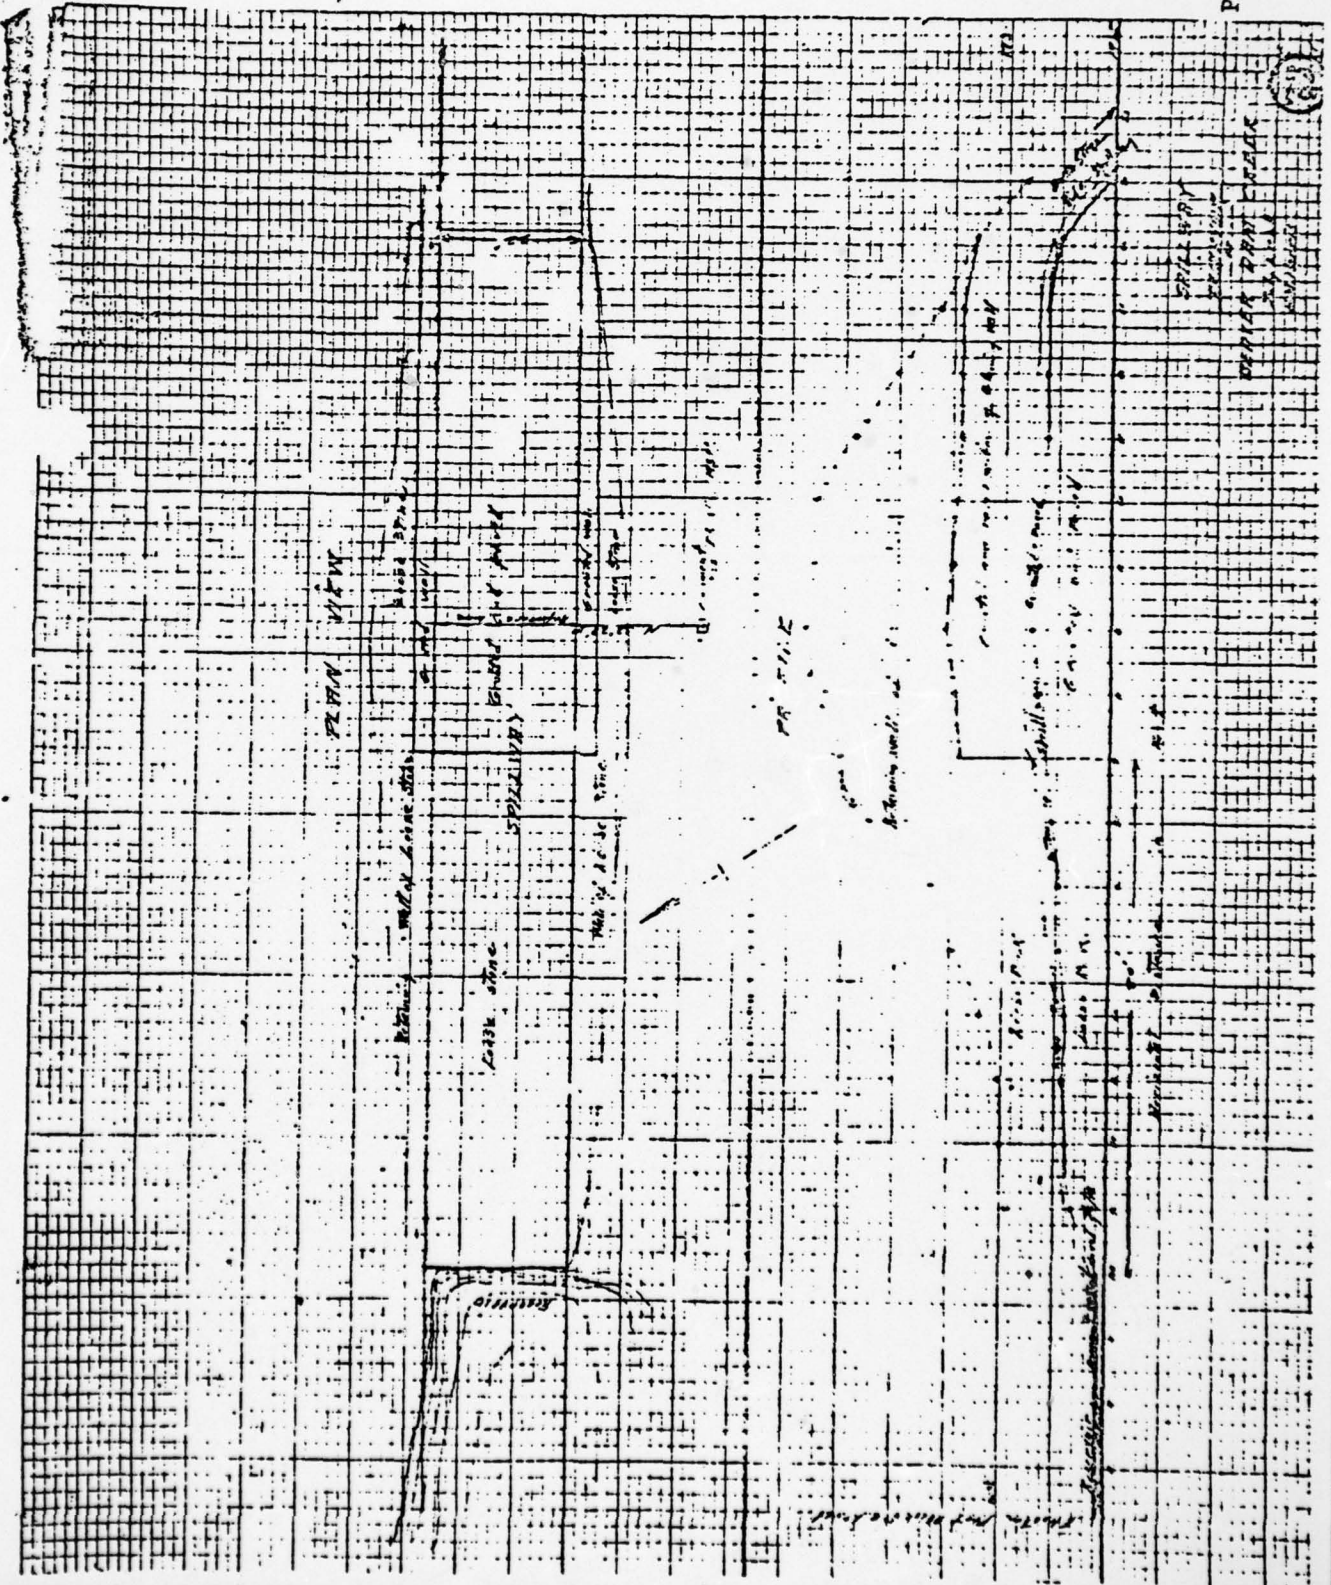
# PLATE III

1. Sketch made from field notes.
2. Spring is the one noted on PLATE I and noted in "Geology Report, Appendix IV."
3. Seep is one noted in 3 May 79 inspection.

- a. All the heavy vegetation, brush, and root systems should be removed from the dam embankment. All subsequent holes should be dressed with compacted fill and seeded.
- b. The seep located in the downstream right abutment should be monitored for erosion during periodic inspections. If erosion should develop, then the services of a qualified geotechnical engineering firm should be retained to recommend immediate remedial measures.
- c. An annual maintenance and inspection program should be initiated to help detect and control problems that may occur.

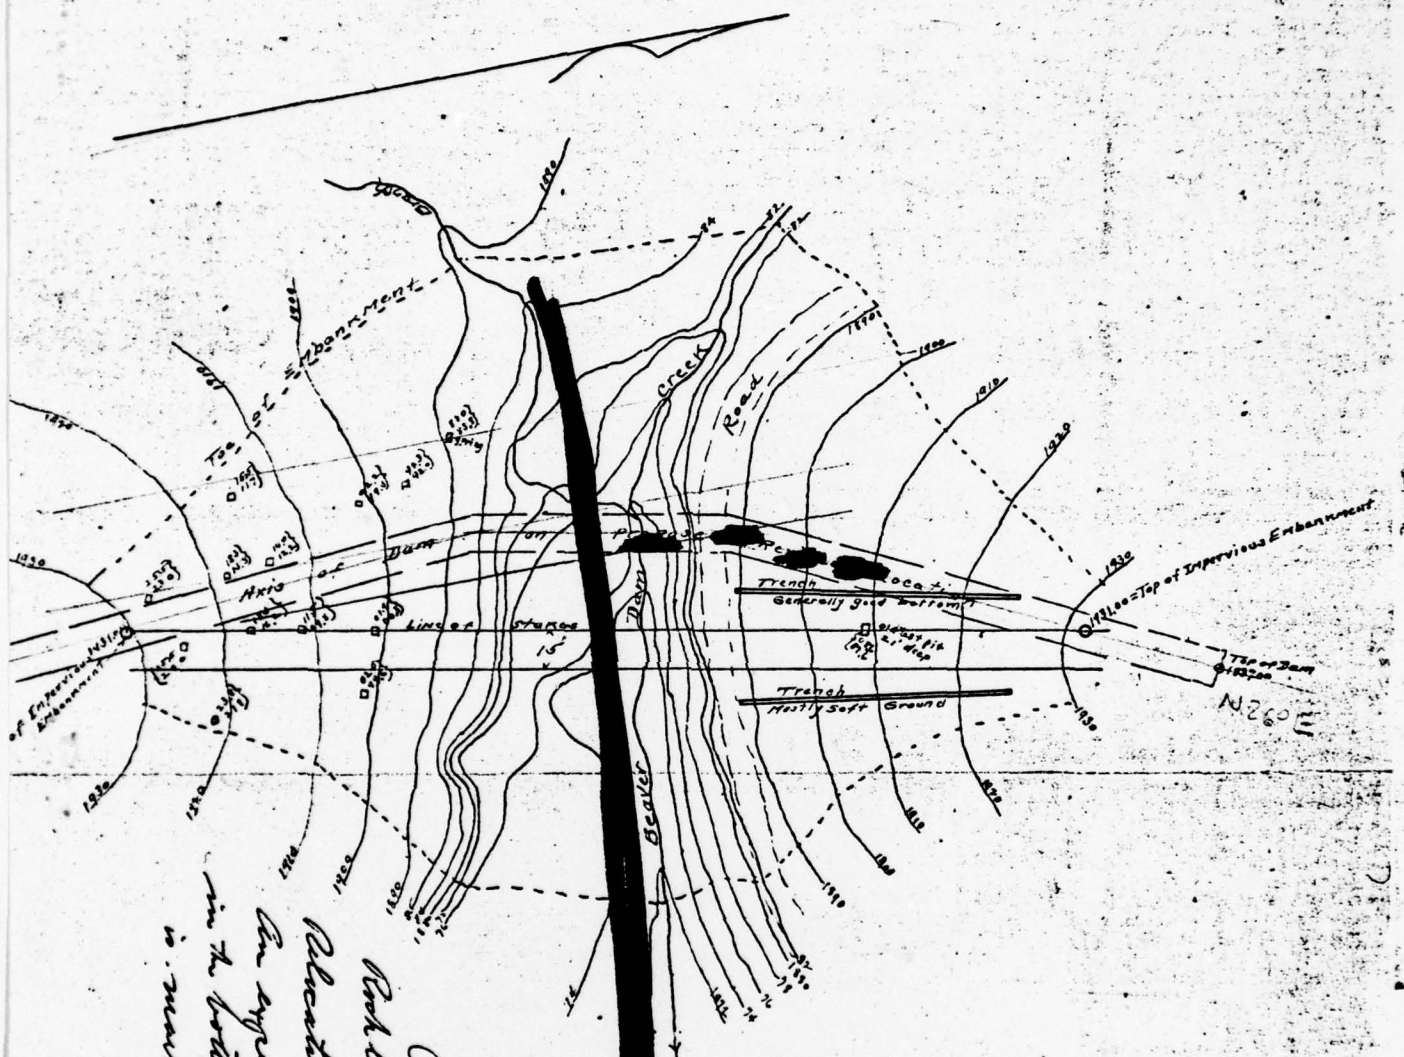
Plan of the site  
 Rock ledges marked in red.  
 Elevation indicated  
 An expected deep zone  
 in the bottom of the valley  
 is marked in green
